CAMDEN RAILWAY STATION

A REMINDER OF INCESSANT GOVERNMENT UNDER-FUNDING OF THE NSW RAIL SYSTEM

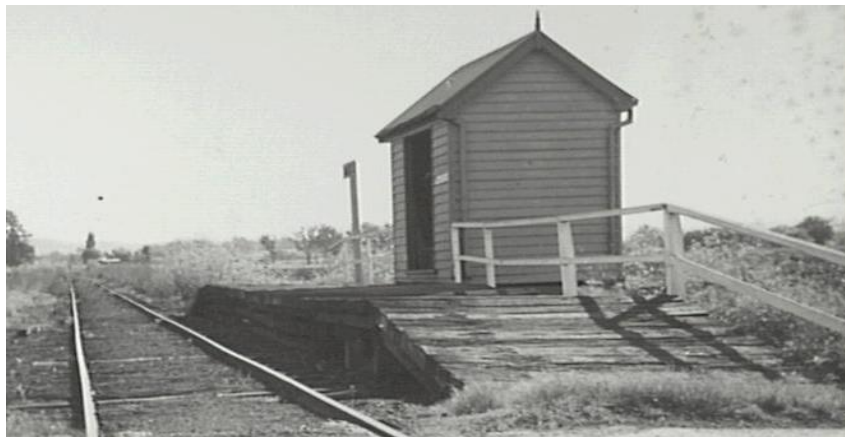
*A pre-1960 photograph of the building at Kirkham, which was reportedly the original terminus waiting shed. The design of the waiting shed was consistent with the use of small, timber structures with gabled roofs and without platform awnings up until 1889, though it was only one of two designs for waiting sheds used between 1855 and 1889. It was relocated from Camden to the then named Kirkham Lane in 1883. The only touch of elegant was the provision of turned timber finials on the roof gables. Finials were also bestowed on the Camden goods shed and are identifiers that the buildings date from the 1880s. **SOURCE:** Ref. No. CHS (Camden Historical Society) 1297.*

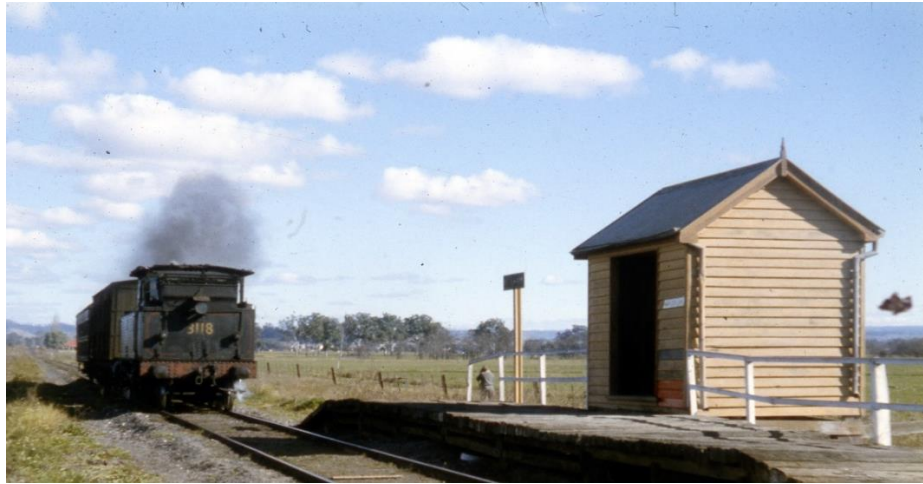
Kirkam station in the 1960s. Note the simple design and the absence of a platform awning, both features that indicate limited funding. The structure is painted in the traditional 'stone' colours, which were in use up to 1951. **SOURCE:** ARHS Resource Centre photograph No. 161707.

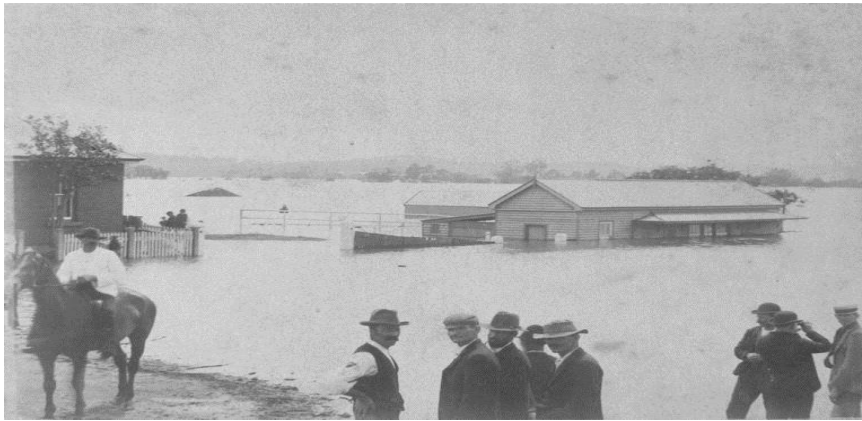
*The photo above appears to be the passenger station building erected in 1883. This location is at the corner of Argyle and Edwards Streets. It was this building that was relocated and slightly altered to the final site of the station in 1901. This structure also featured timber finials on the roof gables, though smaller in size than those applied to the 1882 waiting shed at the then terminus. Note the Station Master's residence adjoining the station on the left. The residence is enclosed by a fence of the then normal design of pickets in the front and palings on the side and rear boundaries. The photograph was taken in the 1898 flood. **SOURCE:** Ref No. CHS 1663*

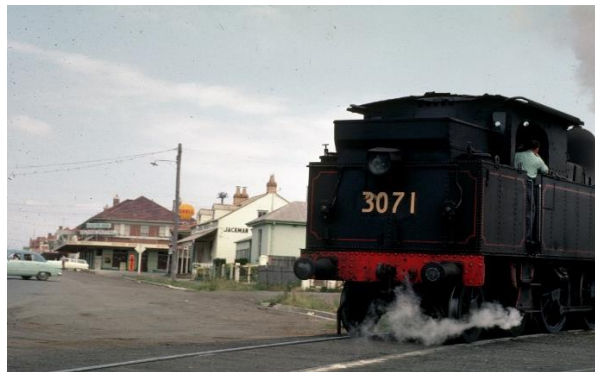
*This 1962 photograph partly shows the Station Master's residence facing Argyle Street adjacent to the entry gate to the goods yard office. The photographer is standing at the intersection of Argyle and Edward Streets. She or he is facing Elizabeth Street, marked by the hotel, which provided the pedestrian and vehicular entry to the passenger station. The verandah of the Station Master's house has been enclosed sometime after construction. The pastel green colour denotes the 1951 decision by the Department to abandon the use of the three tones of 'stone' colour. **SOURCE:** ARHS Resource Centre Photograph No. 061313.*

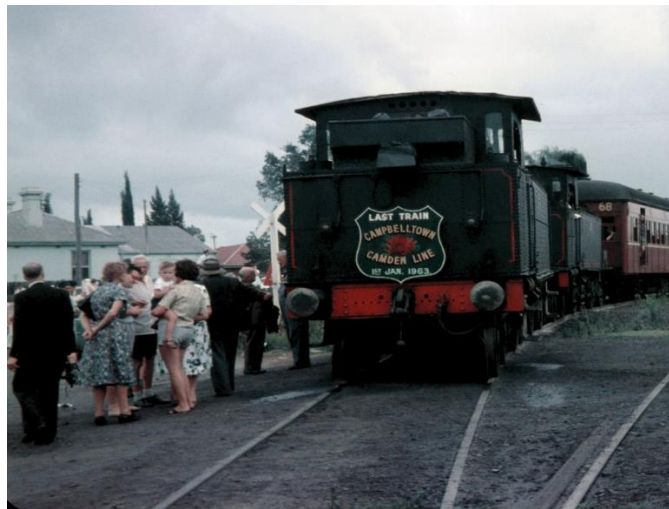
The Station Master's residence is at the extreme left of the photograph. SOURCE: ARHS Resource Centre photograph No. 068901.

George Cowdery was the Engineer in Chief for Existing lines when he approved the construction of the house for the Station Master on 11th June 1889. It was of brick construction and its primary design feature was the asymmetrical front elevation, which resulted in the front verandah extending only halfway across the structure. It was a very modest house but of a very contemporary design with all rooms attached to the structure, including the bathroom, laundry and toilet.³ The building was erected alongside the 1883 passenger station and, after that structure was moved in 1901, its position was not too far from the good shed.

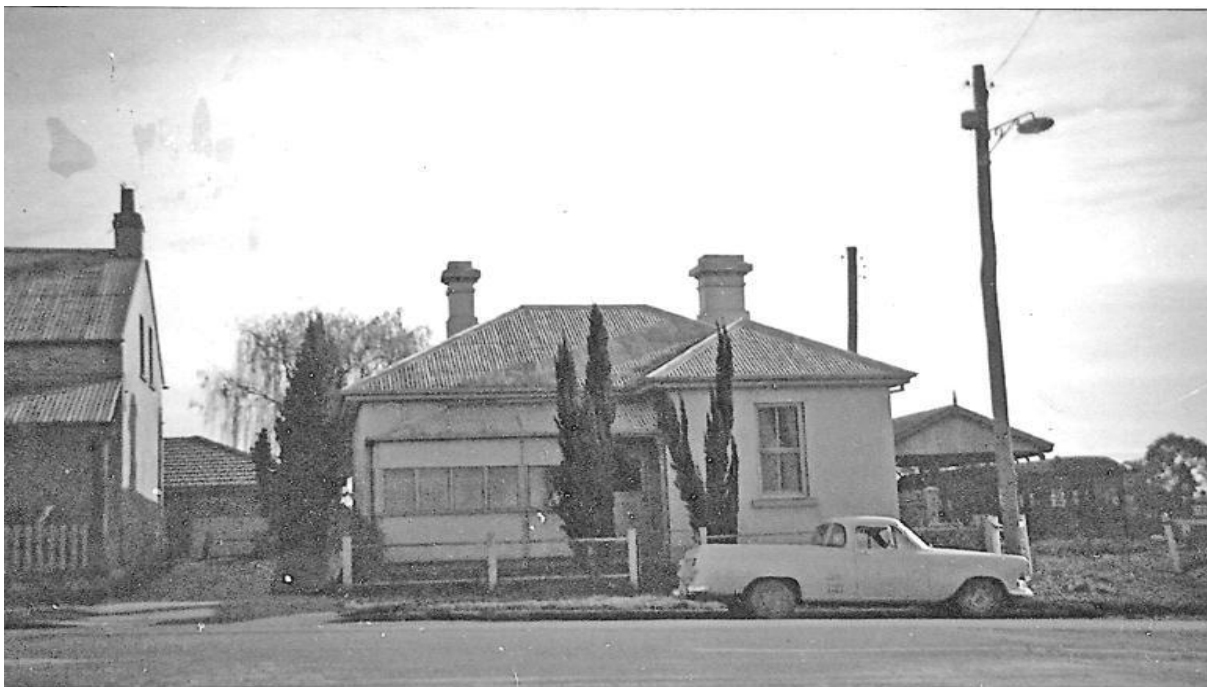
*The Station Master's house looks decidedly grubby, as did the rest of the local railwayscape at Camden – and, for that matter, everywhere. George Cowdery intended to place the verandah on the right-hand side, according to the plan. It will be noted that the front verandah has been enclosed. A part of the good shed is seen to the right side of the photograph, which was taken in the 1960s. **SOURCE:** Ref. No. CHS 2517.*

The residence was built in reverse to the plan. The plan indicates that the front verandah was to be located on the Nepean River side of the structure. But that did not occur. The verandah was placed on the Elizabeth Street side, possibly to give the

A comparison of the photograph overleaf of the structure as constructed and the above plan indicates that the residence was built to the reverse of the intention.

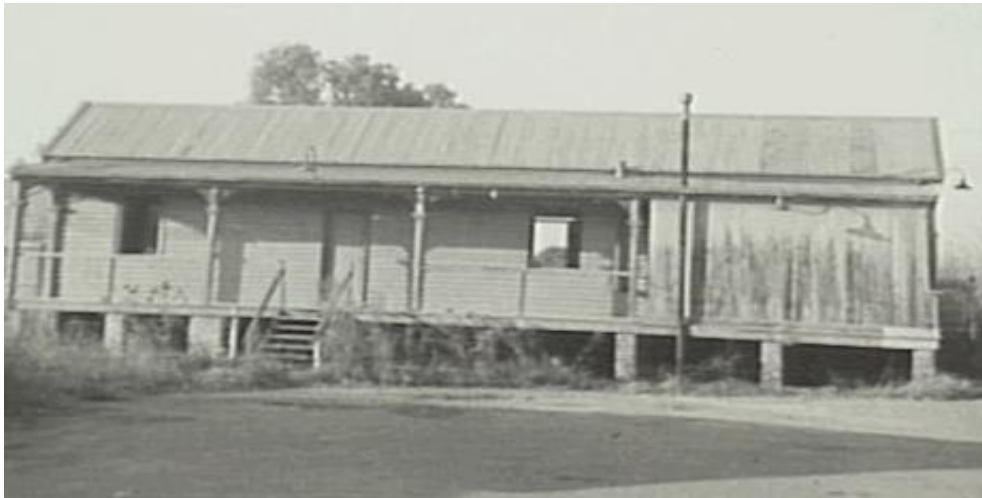
*The above photograph shows the building a year after the termination of services. It shows the 8 steps leading from the forecourt to the verandah. The single door leads to the general waiting room and ticket window. The enclosed wall at the Sydney end houses the extension to the parcels office and was a rare example of vertically-set weatherboards. A steel flue reaches above the ridge of the roof and vents the cast-iron stove-type heater in the Station Master's office. The vertical posts supporting the verandah awning were once used to support the platform awning but were removed upon relocation in 1901. **SOURCE:** 1964 Ref. CHS 1143.*

While the former State Rail Authority Archives Officer, John Forsyth, wrote that the building at the new site was a “new” structure, this was not the case. There are several indicators that reveal the 1883 building was moved to its new location rather than a completely new structure being built. The indicators are:

- both structures match in terms of overall dimensions and scale,
- the use of a single entry door, with outside incandescent lights, from the rear verandah leading to the general waiting room,
- both structures featured the same plainness in design,
- both structures feature the use of vertical awning posts,
- the rear verandah at the new location featured timber capitals cast-iron brackets on the awning posts – a design feature which had fallen out of departmental use by 1901,
- the absence of brick chimneys and other architectural details such as finials,
- the existing Departmental practice against waste which would have occurred if 1883 building had been not re-used.

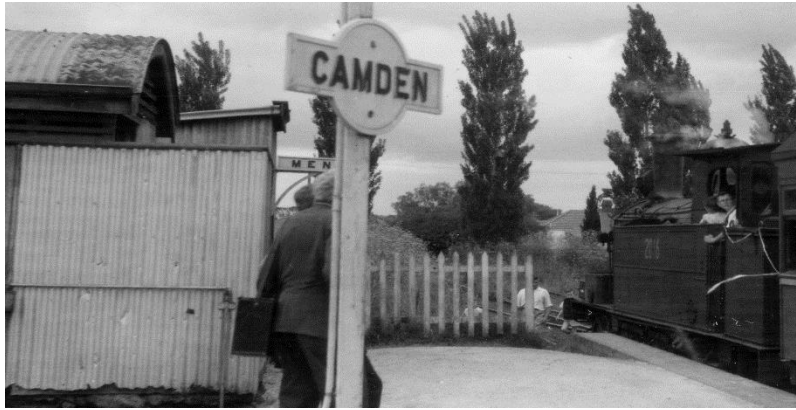
*The above photograph shows the male toilet and lamp room at the terminus end of the platform. The male toilet conformed to the design of off-platform toilets used in rural areas and this was the case at Camden until 1928 when the male toilet was relocated from the rear of the platform to the platform. The classic features of the toilet were, firstly, the use of a timber frame with the walls and roof covered with galvanised, corrugated iron sheets and, secondly, the use of a concave roof. Not many people waiting for a train would stand near the male toilet on the platform because of the adverse odours. **SOURCE:** ARHS Resource Centre photograph No. 103108.*

From the opening of the third station site in 1901, the male toilet and the lamp room had been located behind the ramp leading to the platform at the terminal end. In November 1928, approval was given for the relocation of both of these structures to the terminal end of the platform. They remained in their new locations until the closure of the station. Both structures had timber frames and were clad with corrugated iron and had concrete floors four inches thick placed on top of nine-inch-wide by three-inch-thick timber decking. The male toilet contained two earth closets, being of the standard Department size of five feet by three feet. There was also a three-stall urinal constructed of No. 22 gauge iron sheets with an iron trough 12 inches wide filled with sawdust. Each stall was a standard two feet wide and was protected by a privacy partition 18 inches wide. There was a notation on the plan that the old materials were to be re-used “as far as possible”. The pans in the closets were changed by male staff

While the male toilet had a barrel-shaped roof, the tiny lamp room had a single-pitched roof sloping to the rear. Both rooms were covered with corrugated iron sheets, that for the toilet being curved and that for the lamp room being flat. These structures were the last improvements to the station before it was closed on 1st January 1963. The punchline was that no improvements were made to Camden station after 1928.

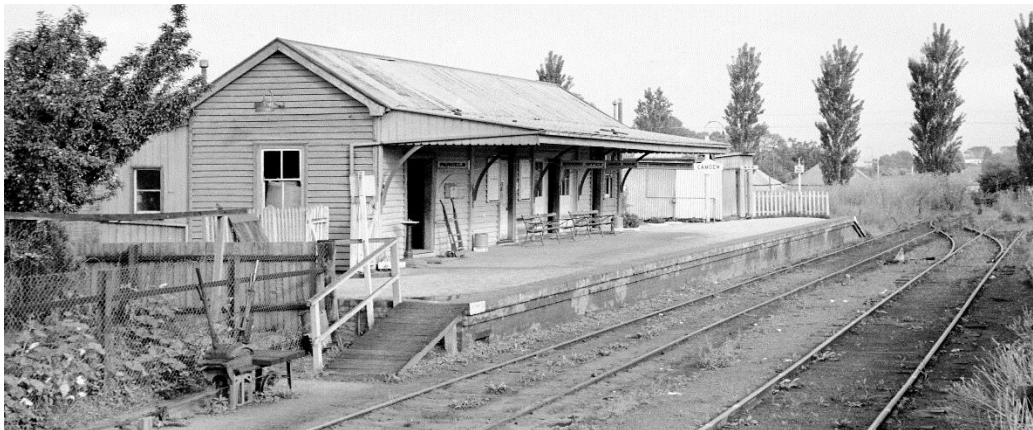
*This photograph shows the following features: two-lever interlocking ground frame; primitive nature of the timber ramp at the Sydney end; extended brickwork of the platform; vertical boarding on the parcels office extension; cantilevered awning brackets; single station name board and male toilet and lamp room at terminus end. **SOURCE:** ARHS Resource Centre photograph No. 22A 003.*

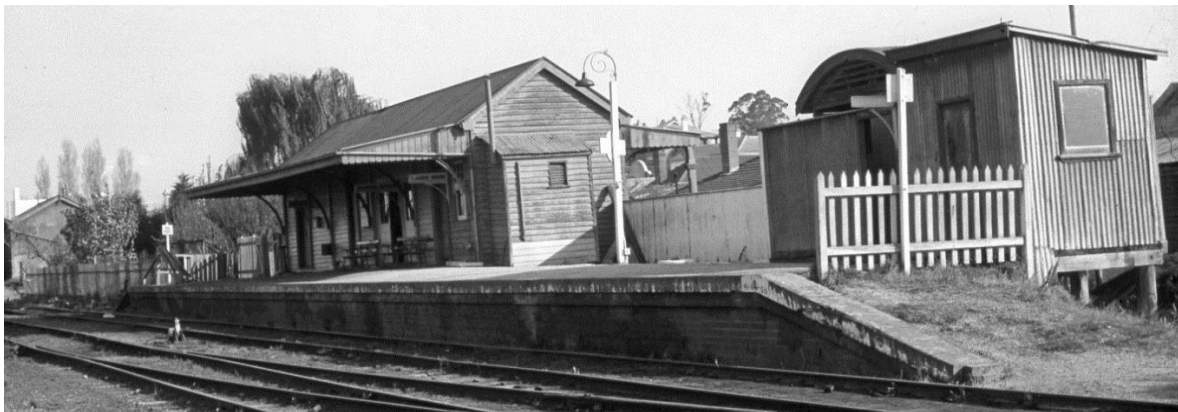
This photograph clearly shows the extension of the ladies' waiting room at the terminus end to provide for a single female toilet closet. The two buildings at the right of the photograph are the lamp room with the single-pitched roof and the male toilet next to it. These were relocated to the platform in 1928 and represented the last improvements to the station. Another ugly addition to the station was the provision of a corrugated iron fence between the male toilet on the main building. Note in the background the very close residential development that abutted the station, which probably induced the Railway Department to sell the station site to obtain revenue.
SOURCE: ARHS Resource Centre photograph No. 540014.

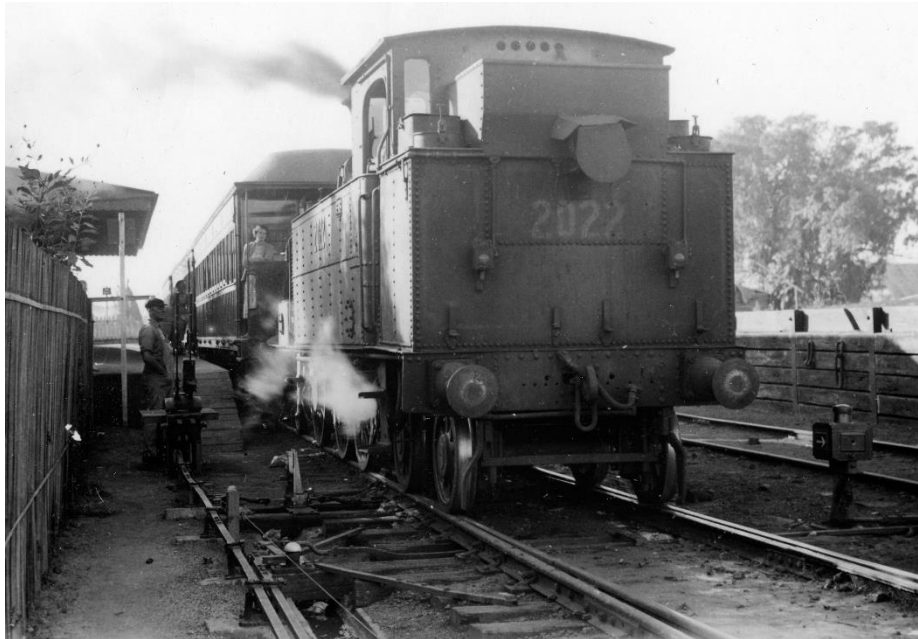
SOURCE: photograph No. 014037, ARHS Resource Centre

Graham Harper provides the caption to the above photograph. He writes:

controlled by lever and bracket lock C, along with the loop points. Lever and bracket lock C were located a crossover length towards Sydney, and on the opposite side of the running line from D. The rodding presumably ran via the "D" rodding run to avoid creating further trip hazards in the relatively clear area between the loop and the loading bank".
